Hastings Sierra Leone Friendship Link

# SANITATION PROJECT

# REVIEW

FEB 26

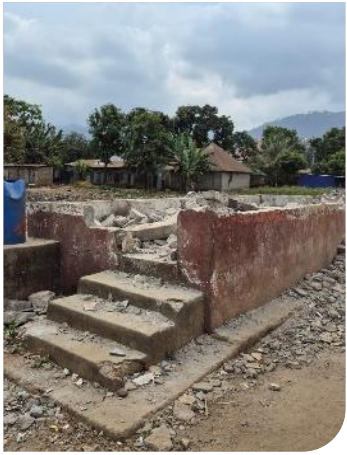
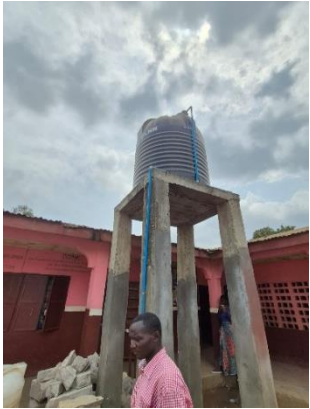
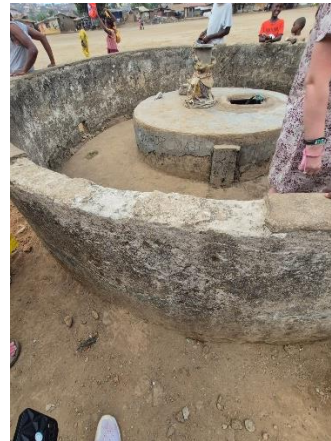
# GRAFTON MODEL BAPTIST

While we were originally informed that everything was working satisfactorily, there were multiple issues.

- Local vandalism had resulted in the hand pump being broken and removed.
- No access to mains power rendered the submersible pump useless.
- Exposed cabling was left by the well to allow a generator to be attached to run the pump. As they do not have generator, they claim to periodically borrow one. This seems unlikely, given the frequency they would need to fill the tank.

Water was extracted using a rope and bucket, demonstrating it is not dry yet which is often the case, even early in the dry season.

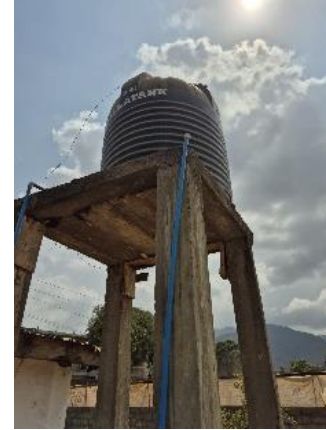
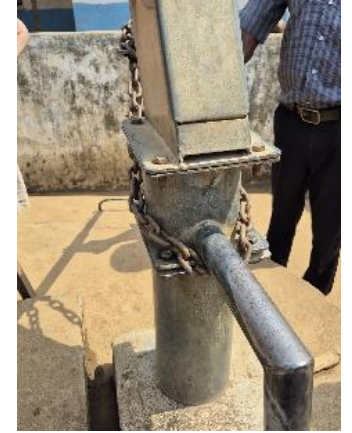
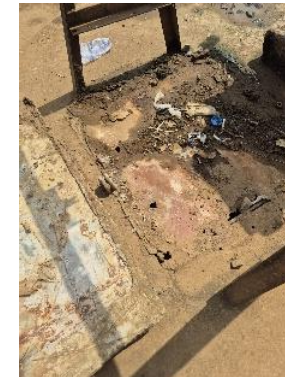
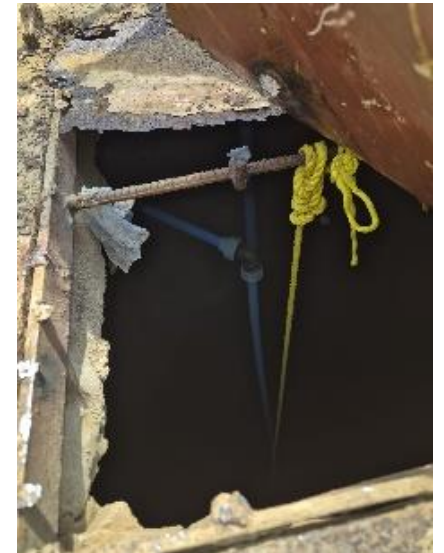
# REC MAYNARD

We had conflicting reports as to why this project had failed. Pipework to water tower was visibly incomplete/damaged. Staff on site advised there wasn't a pump fitted so it would never have worked. They also demonstrated a fault with the handpump. As the opening was welded shut and had a heavy stone (it took 3 of the larger men to move!)

Similar to other schools, Maynard also lacked a power source to be able to power the submersible pump, so at the point of installation, it would only ever have worked as a manual hand pump.

I asked if a similar solution to Grafton could work with a generator being used. Kainde suggested that they did leave a similar connection point but that this had since been covered over. He also advised that the hand pump should be a simple replacement bolt. The submersible pump had been recovered but as unused for a prolonged period, had evidently seized. We did pay Kinde to send this away to be repaired and I understand it was returned and shown to work. The submersible was returned the following afternoon and a generator used to test the system which appeared to work. A further update will be required to ensure the pipework to tower is sufficient for the system to work.

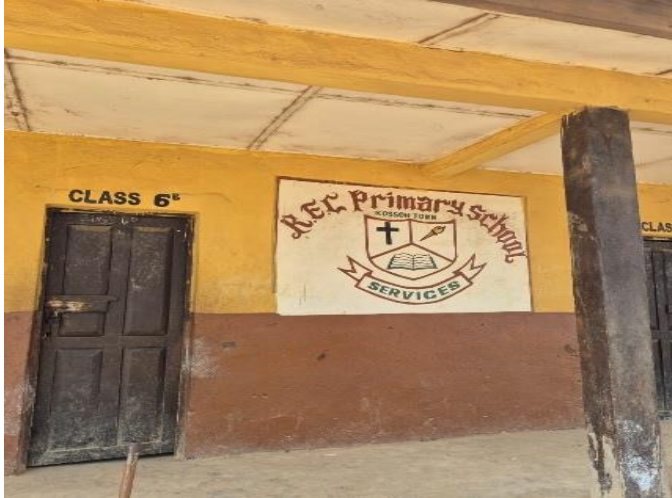
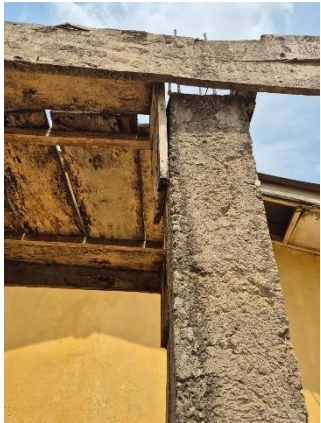
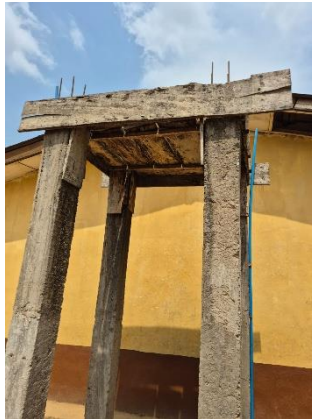
# REC PRIMARY KOSSOH TOWN

- Contractor started work but tower incomplete. Advised that pipework from well had been completed but contractor failed to complete works. When questioned why they had been paid for incomplete job, Kainde advised that the previous jobs all completed without issue, so they trusted enough to release funds to complete works. Apparently, the contractor had a more lucrative contract with the Chinese and they have been uncontactable, despite best efforts.
- Similar to Grafton, there is no power supply to the school to run the submersible pump, and it appears the well has not been deepened. Suffian lives immediately behind the school and mentioned that if works were to be completed, he would gladly use his own electric supply from his home to run the pump.

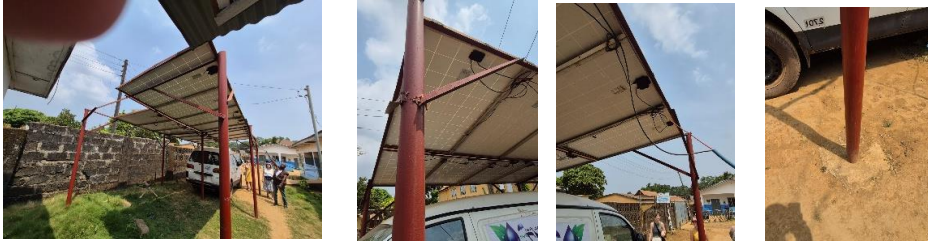
New structure for solar panels appears reasonably sturdy and fir for purpose, housing all but a couple of panels that remain on the main building roof. Cabling from structure to main building has dropped, creating a hazard and also collecting water within the conduit.

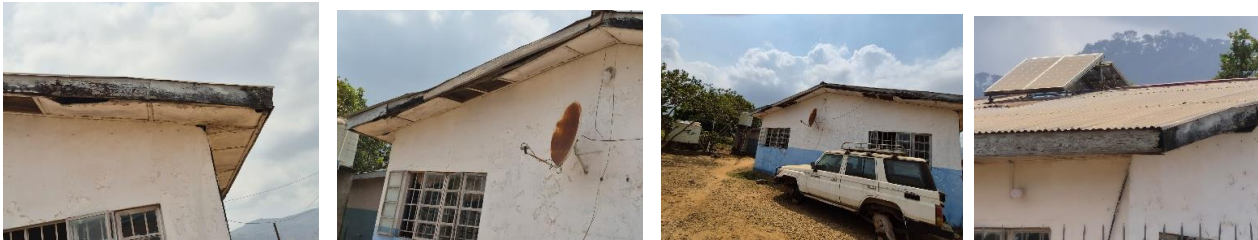
While the roof panels looked to be in good condition, the soffits and fascias were not included in the quote for roof works and are in very poor condition.

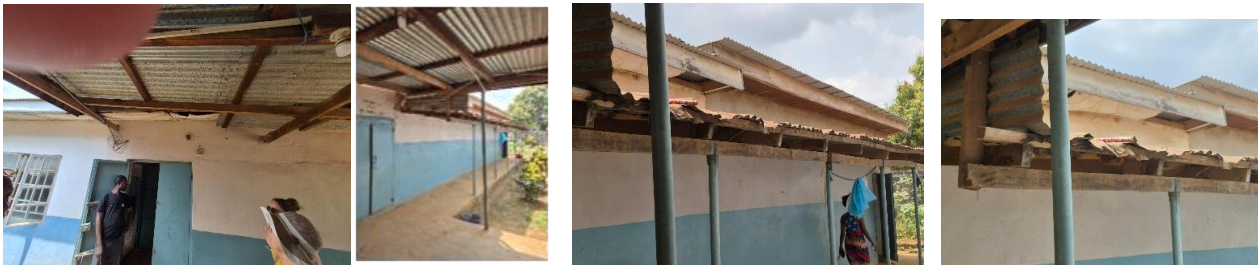
External area to rear, including passageway to adjacent building. Roofing to these areas were not included in original quotes roof works and in very poor condition.
