A Report Prepared for the Hastings-SL, Hastings-UK Link

STATUS OF WASH FACILITIES IN SELECTED SCHOOLS IN HASTINGS-SL

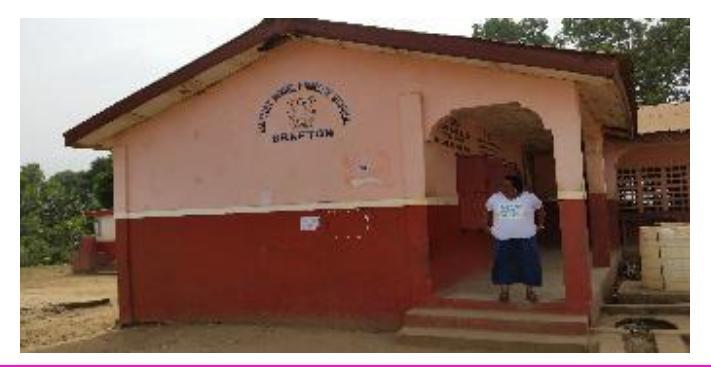
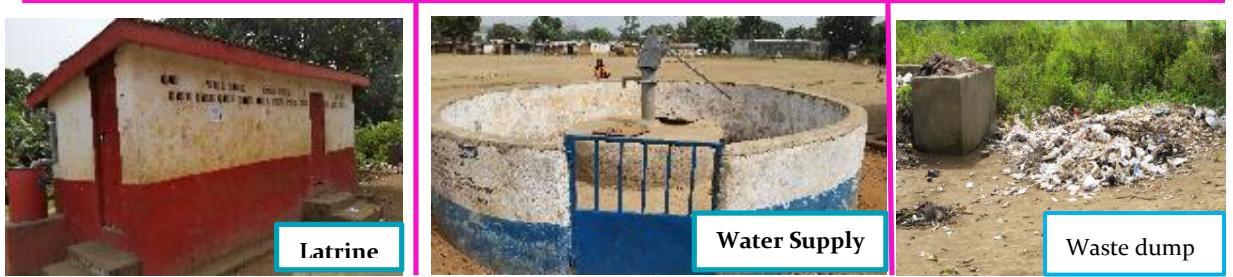
ANNEX – 2: WASH PROFILE IN NEW BAPTIST MODEL PRIMARY SCHOOL, GRAFTON

Service Type	Technology Option	Status	Comment	Proposed Improvement
Water Supply	HDW fitted with HP	Not in use, well reportedly dried up	Seasonal problem associated with bad construction	Re-deepen to ensure min. 2.5m water-column Install mechanized pumping and 10,000L overhead storage tank
Sanitation				
Latrine	TPL with 1 drop-hole each for boys and girls	In use and reasonably clean but with offensive smell	Service grossly inadequate and unhygienic	Use water-seal system and provide 8 drop-holes each for boys and girls with separate toilet for teachers
Urinal	No provision made			Provide urinal space for boys
Garbage Disposal	Open space	In use and routinely burn garbage		Introduce garbage sorting and composting practice
Handwashing	No provision			Introduce new design with running water and HW facility within toilet

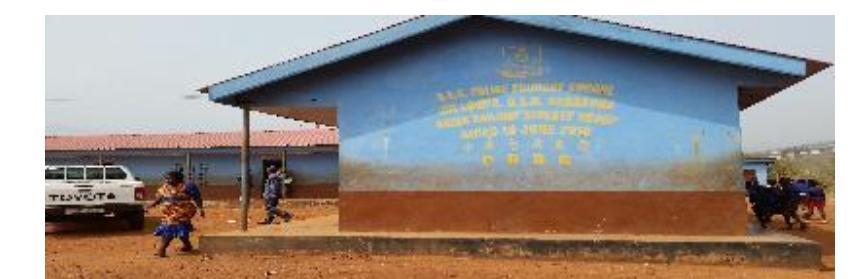
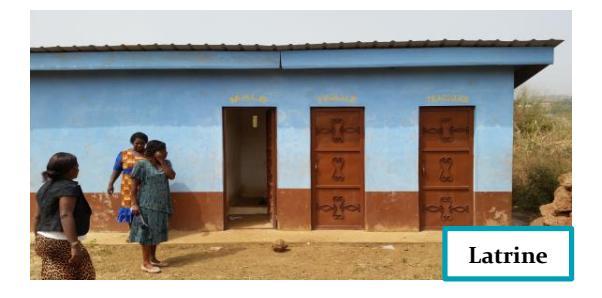
ANNEX – 3	: WASH	PROFILE	IN REC LOWE	R PRIMARY	SCHOOL, JUI
-----------	--------	---------	-------------	-----------	-------------

Service Type	Technology Option	Status	Comment	Proposed Improvement
Water Supply	Not available			 Install BH with mechanized (solar powered) pumping provide overhead storage tank
Sanitation				
Latrine	TPL with 1 drop- hole each for boys, girls and teachers	Kept in reasonably good condition	Service, grossly inadequate and unhygienic	 Adopt water-seal toilet with the following number of drop- holes: boys (6) and girls (7) Provide separate facilities for teachers
Urinal	No provision made			Provide urinal space for boys
Garbage Disposal	Open space	Burn garbage daily	Indiscriminate burning poses health risk to school community	 Introduce garbage separation and composting practice
Handwashing	No provision			 Introduce new toilet design with running water and HW facility within.

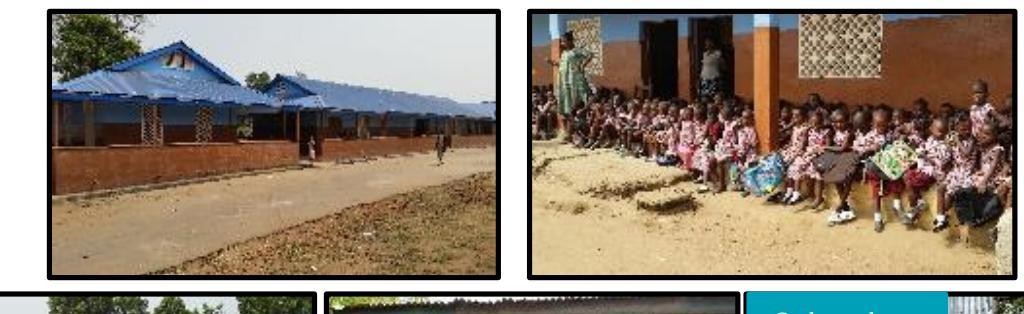
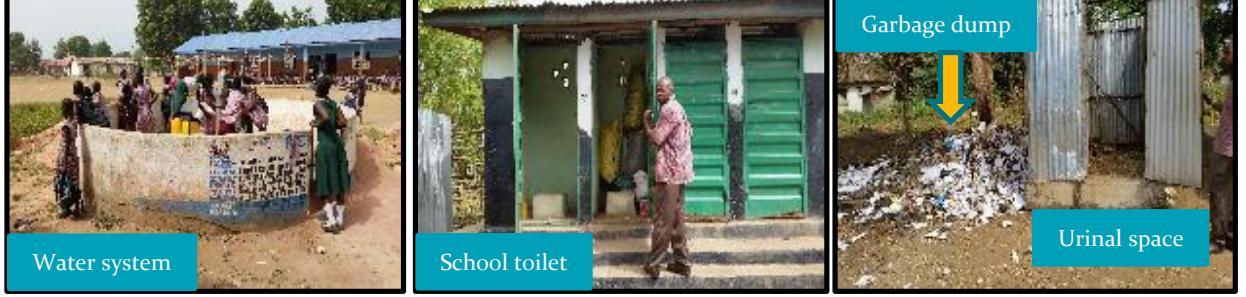
ANNEX – 4: WASH PROFILE IN UPPER INFANT AND PRIMARY SCHOOL, JUI

Service Type	Technology Option	Status	Comment	Proposed Improvement
Water Supply	HDW fitted with HP	Currently functional	Technology choice does not enhance hygiene practice	 Re-deepen well to ensure min. 2.5m water column at peak dryseason Provide mechanized pumping Provide overhead water storage
Sanitation				
Latrine	TPL with the following drop- holes: one each for boys and girls (2) and 1 for staff	Currently in use, albeit partially	Service inadequate and unhygienic	 Adopt water-seal toilet with the following number of drop- holes: boys (9) and girls (10) and separate facilities for teachers
Urinal				Provide urinal space for boys
Garbage Disposal	Open space	Routinely burn		 Introduce garbage separation and composting practice
Handwashing	Plastic bucket fitted with tap	Water available with soap	Facility located away from toilet	 Introduce new toilet design with running water and HW facility within.

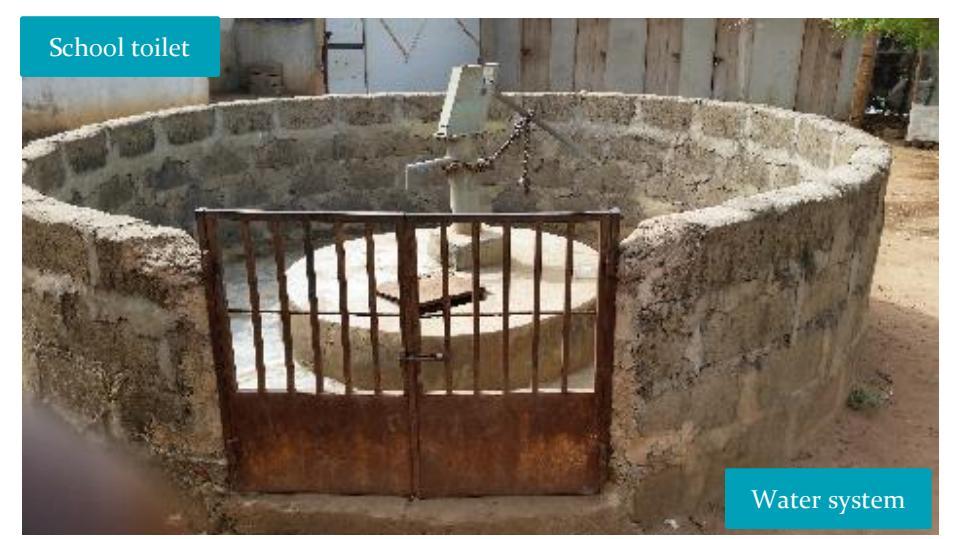
ANNEX – 5: WASH PROFILE IN EDEST, NURSERY AND PREPARATORY SCHOOL, JUI

Service Type	Technology Option	Status	Comment	Proposed Improvement
Water Supply	HDW fitted with HP	Currently functional	HDW within 10m (unsafe distance) from toilet, posing high risk of contamination	 Re-deepen well to ensure min. 2.5m water column at peak dry-season Provide mechanized pumping Provide overhead water storage
Sanitation				
Latrine	TPL with the following drop- holes: boys (1), girls (2) and 1 each for male and female staff	Currently in use	Service inadequate and unhygienic	 Adopt water-seal toilet with the following number of drop- holes: boys (5) and girls (4) , with separate facilities for teachers
Urinal				Provide urinal space for boys
Garbage Disposal	Open pit	Routinely burn	Indiscriminate burning could be hazardous	Introduce garbage separation and composting practice
Handwashing	No provision			 Introduce new toilet design with running water and HW facility within.

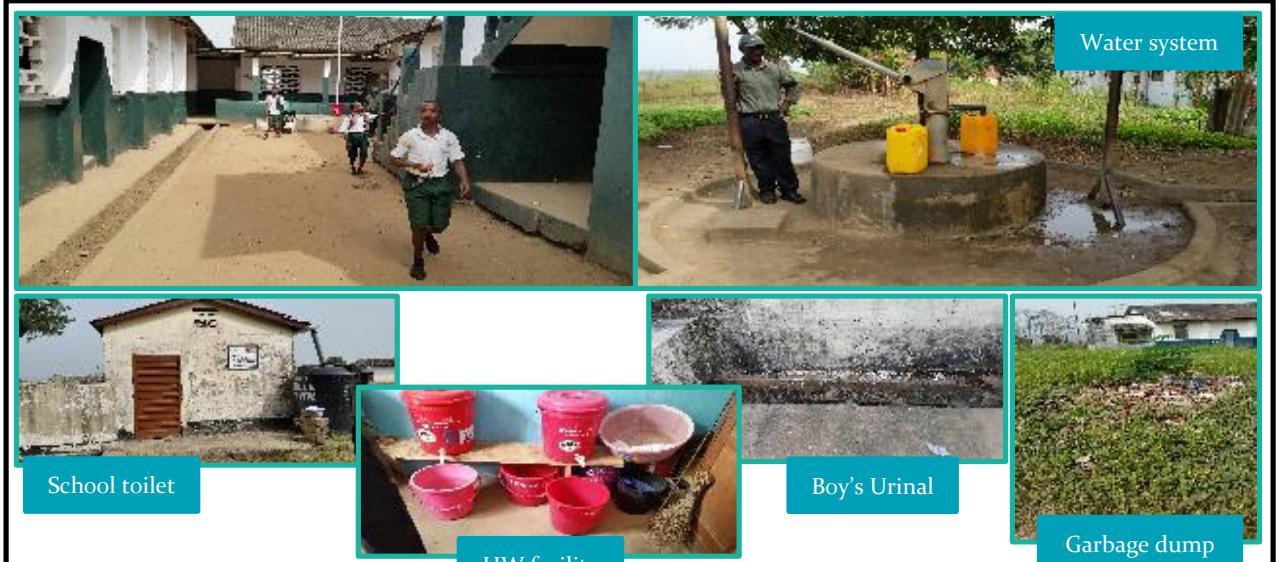
ANNEX –6: WASH PROFILE IN HUNTINGDON SCHOOL, JUI

Service Type	Technology Option	Status	Comment	Proposed Improvement
Water Supply	1 of 2 HDWs fitted with HPs provided within school premises	Both are currently functional	Need for 2 HDWs within school premises, not evident	 Re-deepen both wells to ensure min. 2.5m water column at peak dry-season Provide mechanized pumping Provide overhead water storage
Sanitation				
Latrine	TPL with the following drop-holes: boys (2), girls (3), with separate facility for staff	Students toilets currently in use, but staff, not in use	Services are inadequate and generally unhygienic	 Adopt water-seal toilet with the following number of drop- holes: boys (5) and girls (4), with separate facilities for teachers Provide menstrual management facility in toilet for girls
Urinal	Masonry wall finish	In use	Smelly and dirty	Provide urinal space for boys
Garbage Disposal	Open pit	Routinely burn	Indiscriminate burning could be hazardous	Introduce garbage separation and composting practice

Handwashing	Series of buckets with taps in school hallways	Water is available without soap	Location could inhibit regular handwashing	 Introduce new toilet design with running water and HW facility within.

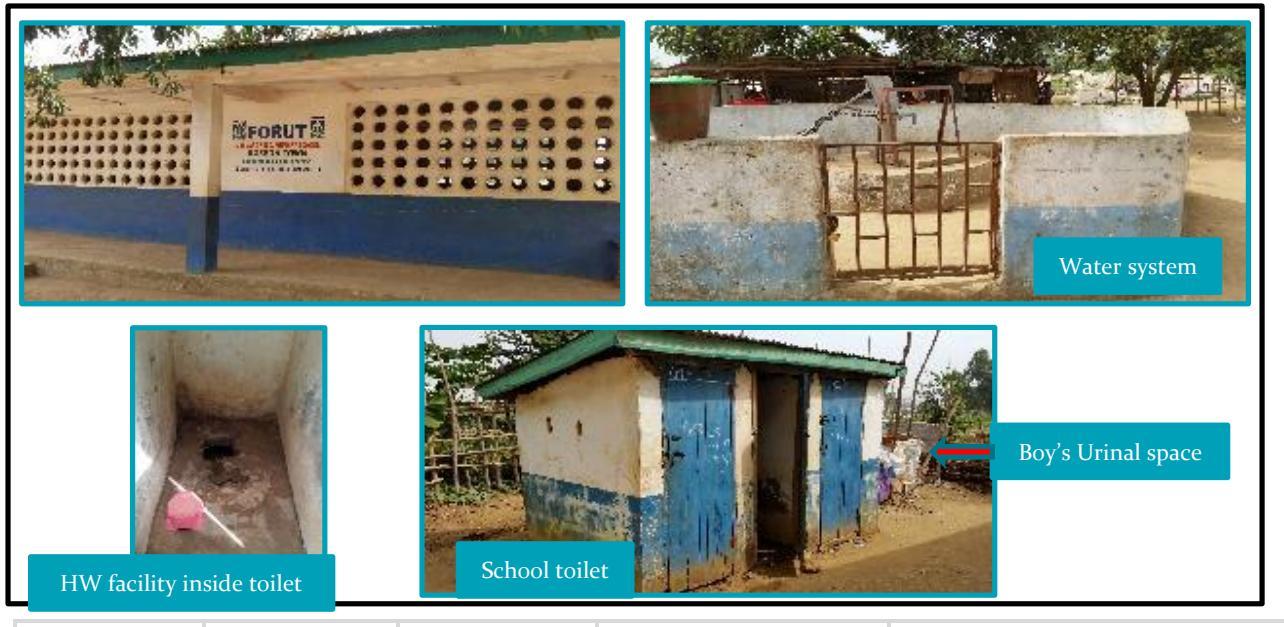
AININEA – 7. WASH PROFILE IN WATNARD SCHOOL, ROSSOH TOWN	ANNEX –	7: WASH PR	OFILE IN MAY	NARD SCHOOL.	KOSSOH TOWN
--	---------	------------	--------------	--------------	--------------------

Service Type	Technology Option	Status	Comment	Proposed Improvement
Water Supply	HDW fitted with HP	Currently functional	Adopt a technology option that will allow running water and enhance hygiene practice	 Re-deepen well to ensure min. 2.5m water column at peak dry-season Provide mechanized pumping Provide overhead water storage
Sanitation				
Latrine	TPL with 1 drop-hole each for boys and girls	Currently in use	Service inadequate and unhygienic	 Adopt water-seal toilet with the following number of drop- holes: boys (4) and girls (5), Provide separate facilities for teachers
Urinal	Fenced space	In use	Dirty and unhygienic	Provide urinal space for boys
Garbage Disposal	Open pit	Routinely burn	Indiscriminate burning poses a health risk to school community	 Introduce garbage separation and composting practice
Handwashing	Plastic bucket fitted with HP	Water available without soap	Located away from toilet and not likely to enhance hygiene	 Introduce new toilet design with running water and HW facility within.

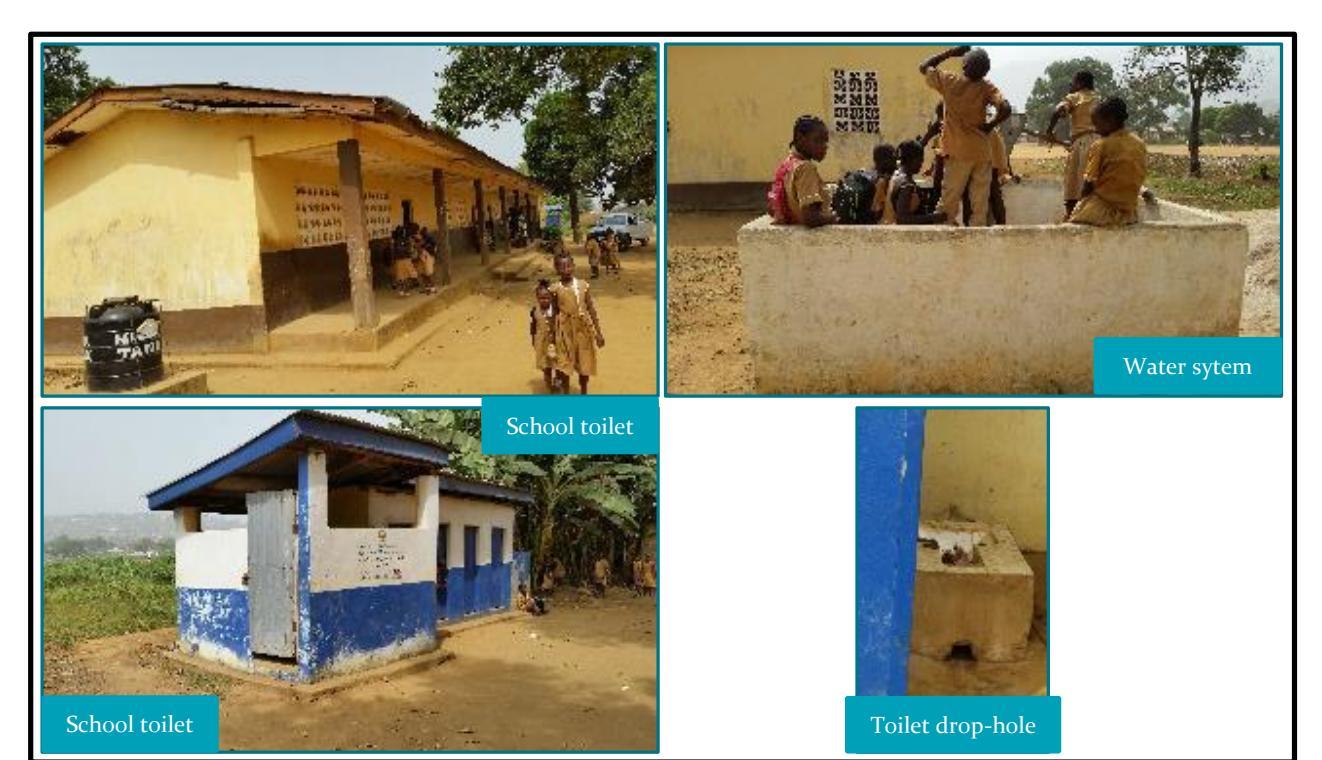
ANNEX – 8: WASH PROFILE IN REC PRIMARY SCHOOL, KOSSOH TOWN

Service Type	Technology Option	Status	Comment	Proposed Improvement
Water Supply	HDW fitted with HP	Currently functional, but reportedly seasonal	Adopt a technology option that will allow for running water and enhance hygiene practice	 Re-deepen well to ensure min. 2.5m water column at peak dry-season Provide mechanized pumping Provide overhead water storage
Sanitation				
Latrine	TPL with 1 drop-hole each for boys and girls	Currently in use	Service inadequate and unhygienic	 Adopt water-seal toilet with the following number of drop-holes: boys (5) and girls (6), with separate facility for teachers
Urinal	Masonry finished wall	Not currently in use		• Provide ceramic finish and running water for cleaning
Garbage Disposal	Open pit	Routinely burn	Indiscriminate burning could be hazardous	Introduce garbage separation and composting practice
Handwashing	No provision			 Introduce new toilet design with running water and HW facility within.

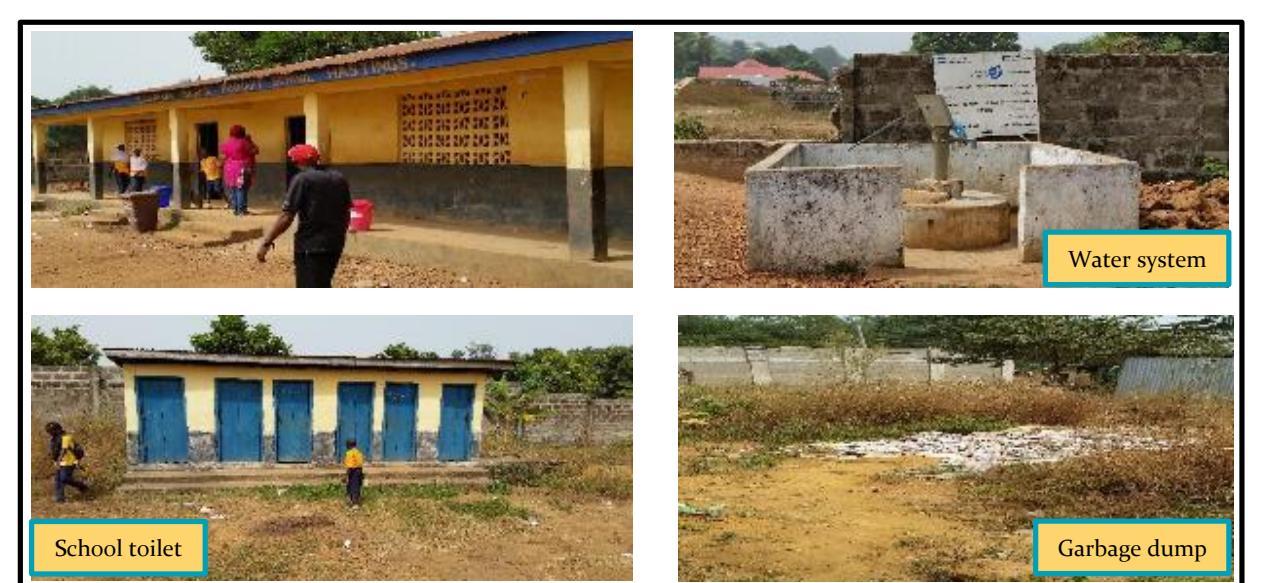
ANNEX – 10: WASH PROFILE IN KANKAYLAY ISLAMIC PRIMARY SCHOOL, HASTINGS

Service Type	Technology Option	Status	Comment	Proposed Improvement
Water Supply	HDW fitted with HP	Currently functional, but shows signs of a leaking cylinder	Adopt a technology option that will allow running water and enhance hygiene practice	 Re-deepen well to ensure min. 2.5m water column at peak dryseason Provide mechanized pumping, otherwise repair source of leaking rising main assembly Provide overhead water storage
Sanitation				
Latrine	TPL with 2 drop-holes each for boys and girls including separate facilities for male and female staff	Currently in use and out- sourced maintenance arrangements	Service is inadequate, generally clean, but unhygienic	 Adopt water-seal toilet design with 3 each drop-holes for boys and girls separate facility for teachers
Urinal	No provision		Urinal for boys is critical to avoid long waiting turns in already stretched latrines	 Provide ceramic finish and running water for easy cleaning

Garbage Disposal	Garbage bin	Burn daily	Indiscriminate burning of waste poses health risks	Introduce garbage separation and composting practice
Handwashing	Plastic bucket	Water available but no soap		 Introduce new toilet design with running water and HW facility within.

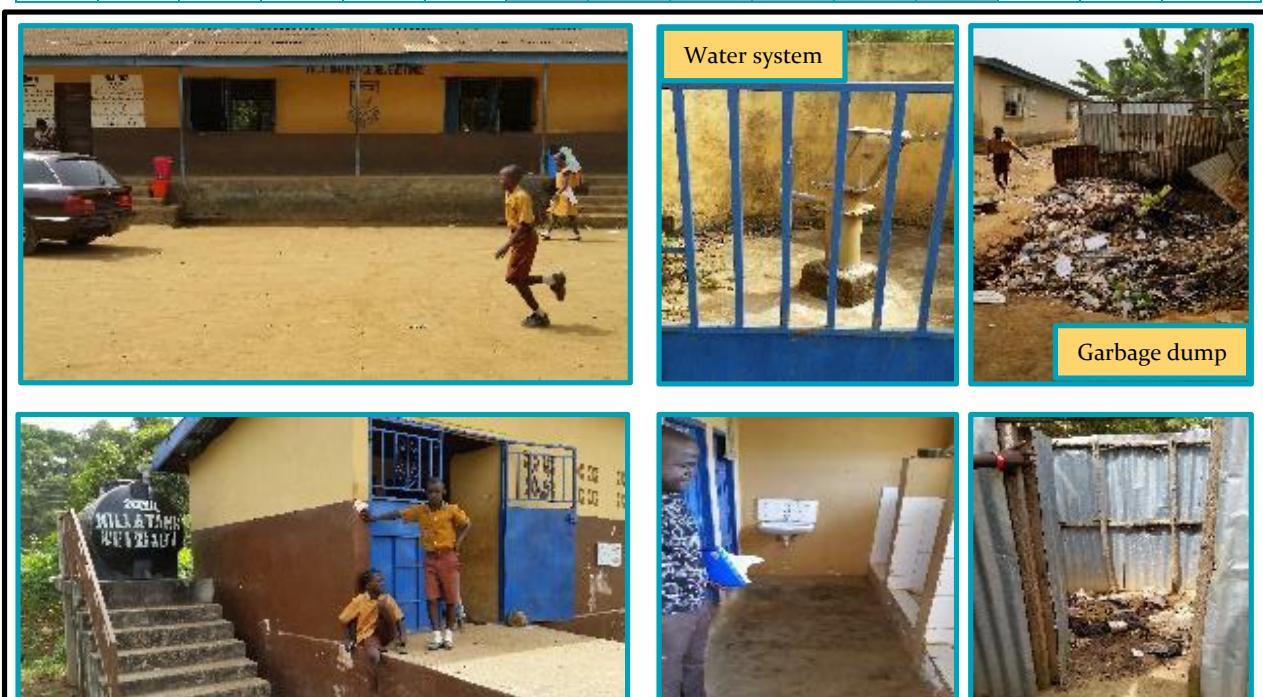
ANNEX – 11: WASH PROFILE IN REC INFANT AND PRIMARY SCHOOL, HASTINGS

Service Type	Technology Option	Status	Comment	Proposed Improvement
Water Supply	HDW fitted with HP	Currently functional	Adopt a technology option that will allow running water and enhance hygiene practice	 Re-deepen well to ensure min. 2.5m water column at peak dry-season Provide mechanized pumping, Provide overhead water storage
Sanitation				
Latrine	 TPL with 2 dropholes each for boys and girls with separate facilities for infant and primary schools Rainwater harvesting system (RWHS) to service toilet 	Currently in use with maintenance arrangements, out-sourced	 Service is inadequate but clean Storage capacity (2000L) for RWHS is inadequate with the result that water supply availability is seasonal 	 Adopt water-seal toilet design with the following drop-holes: Infants (6) each for boys and girls, PS – boys (7) & girls (5) separate facility for teachers

Service Type	Technology Option	Status	Comment	Proposed Improvement
Urinal	In-built within toilet	Functional and well maintained	Additional urinal space is a disease trap	 discontinue use of additional urinal space in place of hygienic extension
Garbage Disposal	Local pit	Routinely burn waste	Indiscriminate burning of waste poses health risks	Introduce garbage separation and composting practice
Handwashing	Ceramic handwashing basin within toilet and additional plastic buckets distributed in locations around school block	Water available but no soap		 Provide additional ceramic handwashing basins within toilet

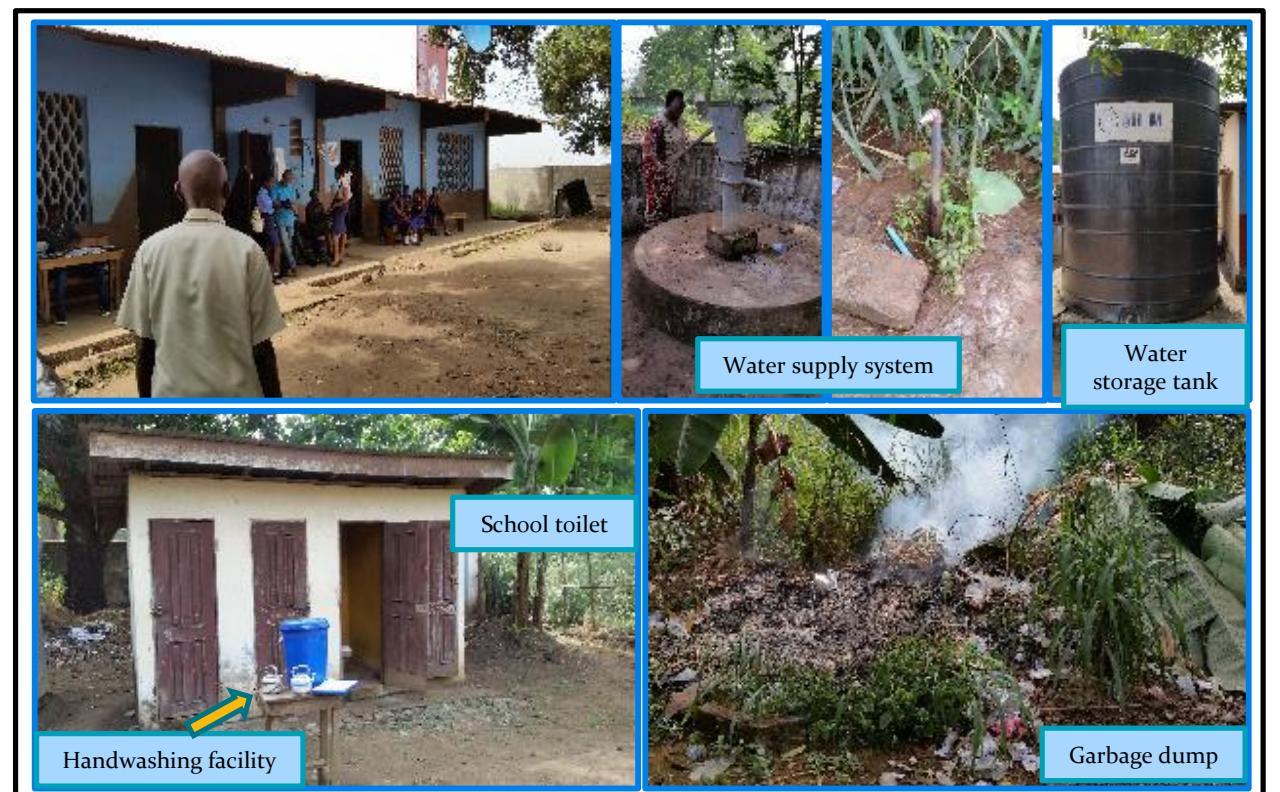
ANNEX – 12: WASH PROFILE IN KELLY'S SECONDARY SCHOOL, HASTINGS

Service Type	Technology Status Option		Comment	Proposed Improvement
Water Supply	 HDW fitted with HP Network system (tap- stand, abandoned) HP currently functional, but shows signs of a leaking cylinder Network water supply system abandoned due unreliable servi Water storage to not in use for la network water 		In short to medium-term fixing HDW with HP is ideal due to chronic shortage of drinking water in Freetown	 Re-deepen well to ensure min. 2.5m water column at peak dry-season Provide mechanized pumping, otherwise repair source of leaking rising main assembly Provide overhead water storage
Sanitation				
Latrine	TPL with 2 drop- holes each for boys and girls including	Currently in use by JSS and SSS in twin shift system	 Even for the current twin shift arrangement, 	 Adopt water-seal toilet design or better, with no more than 5 drop-holes each for boys and girls

Service Type	Technology Option	Status	Comment	Proposed Improvement
	separate facilities for male and female staff		service is inadequate. • Service is otherwise generally clean, but unhygienic	 Provide menstrual management facility in toilet for girls separate facility for teachers
Urinal	No provision		Urinal for boys is critical to avoid long waiting turns in already stretched latrines	 Provide ceramic finish and running water for easy cleaning
Garbage Disposal	Garbage dump	Burn daily	Indiscriminate burning of waste poses health risks	Introduce garbage separation and composting practice
Handwashing	Plastic bucket fitted with tap	Water available but no soap		 Introduce new toilet design with running water and HW facility within.

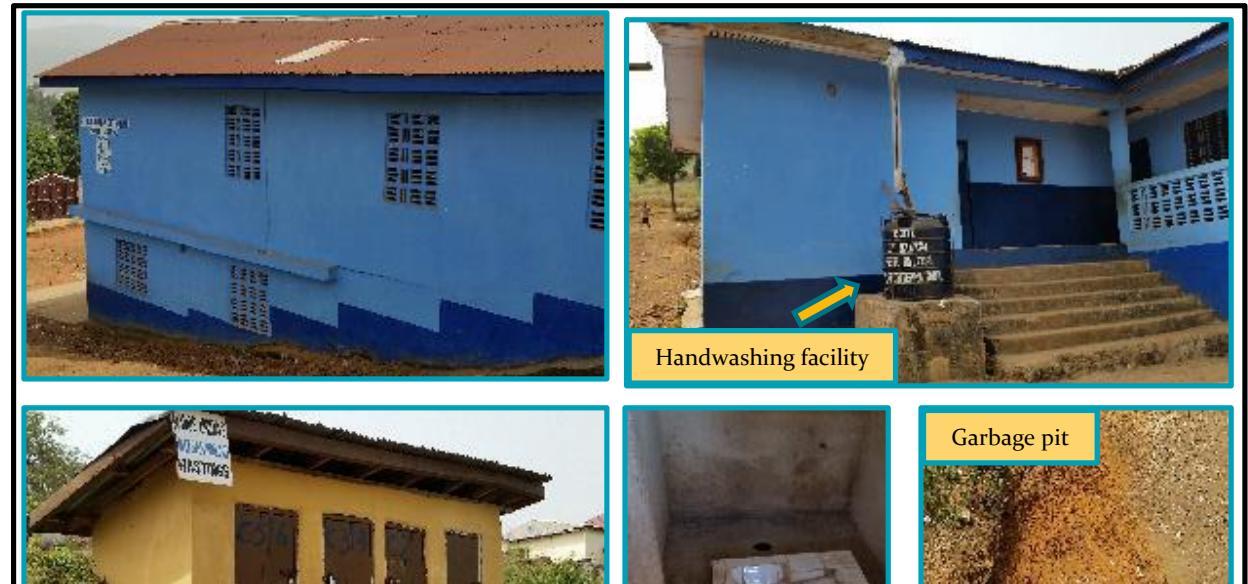
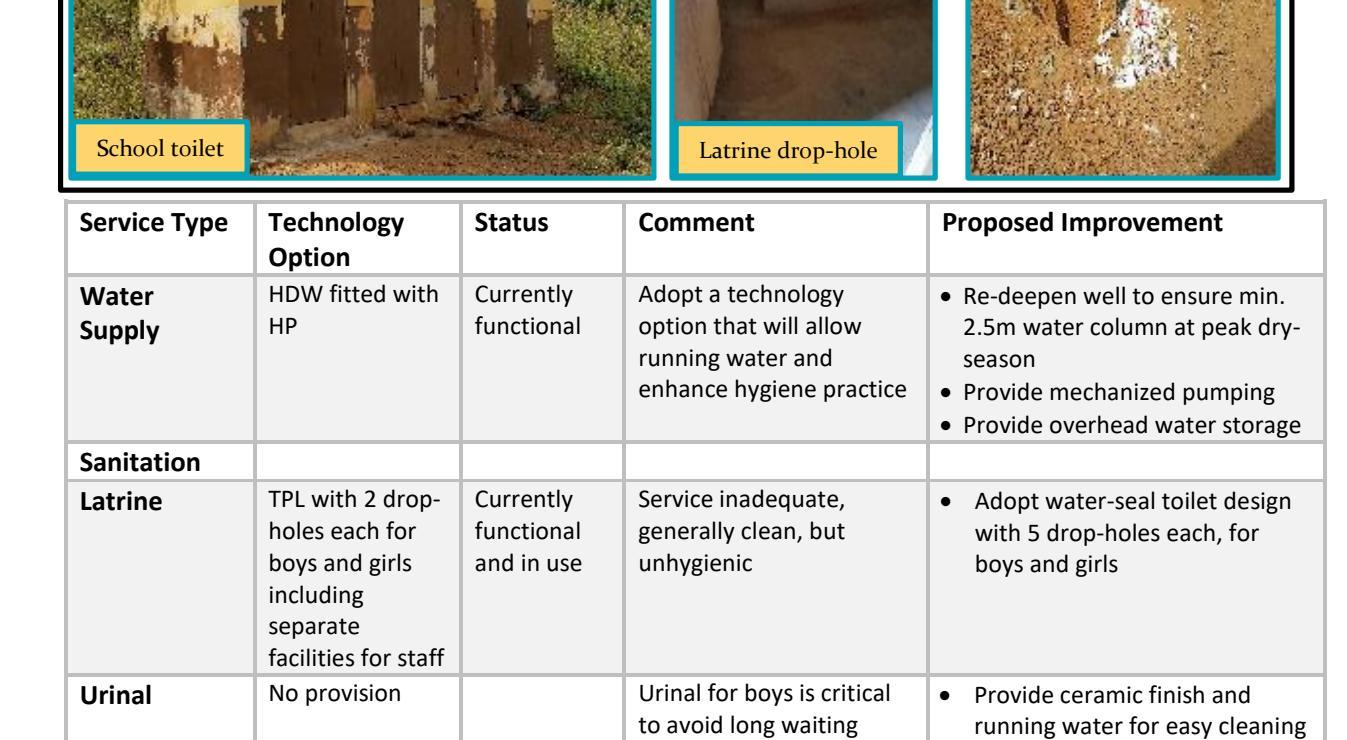
ANNEA – 13: WASH PROFILE IN ST. MULUMBA RC SCHOOL, HASTING	ANNEX – 1	3: WASH P	ROFILE IN ST	. MULUMBA	RC SCHOOL,	HASTINGS
--	-----------	-----------	--------------	-----------	------------	----------

Service Type	Technology Option	Status	Comment	Proposed Improvement
Garbage Disposal	Open pit	Routinely burn	Indiscriminate burning of waste poses health risks	 Introduce garbage separation and composting practice
Handwashing	Tap rainwater through 1000L water storage tank for handwashing	Availability of water is seasonal	Current handwashing arrangement is grossly inadequate and unlikely to promote sustained hygiene behavior change	 Introduce new toilet design with running water and HW facility within.

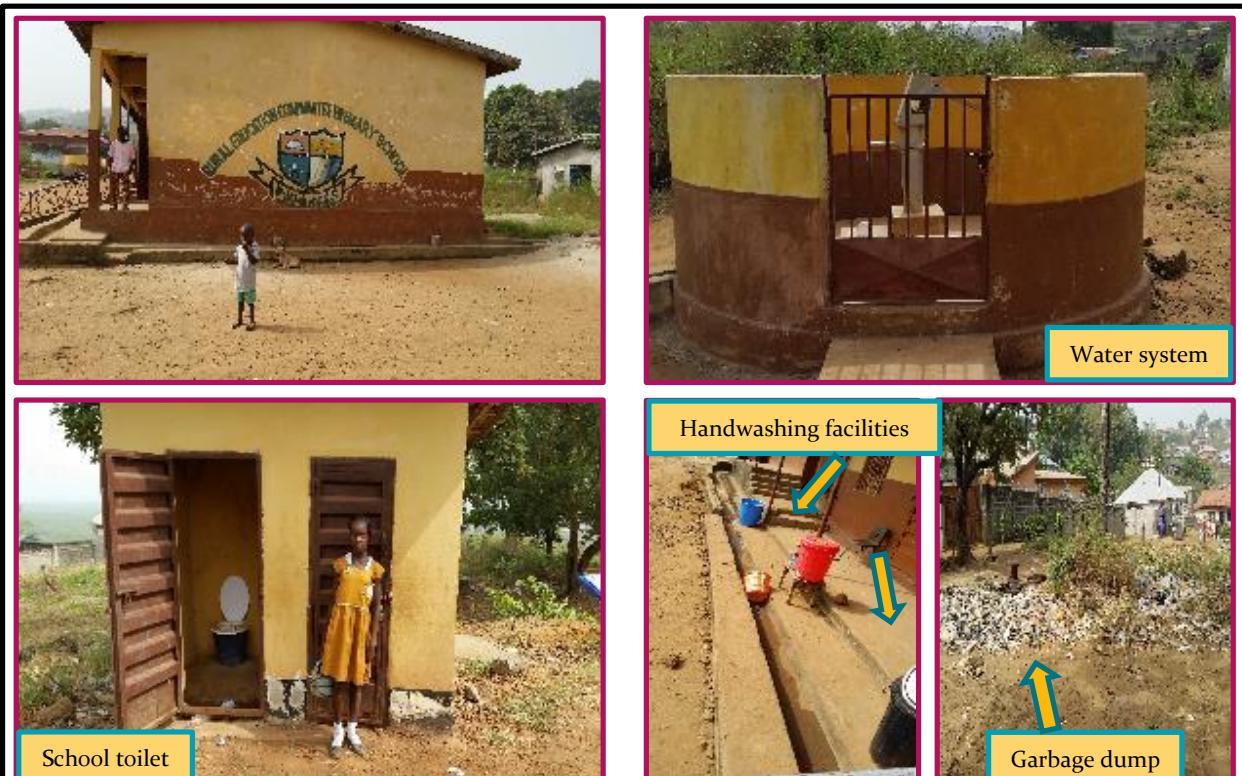
ANNEX – 14: WASH PROFILE IN REC PRIMARY SCHOOL, ROKEL

Service Type	Technology Option	Status	Comment	Proposed Improvement
Water Supply	HDW fitted with HP	Currently functional	Adopt a technology option that will allow running water and enhance hygiene practice	 Re-deepen well to ensure min. 2.5m water column at peak dry-season Provide mechanized pumping Provide overhead water storage tank (10,000L)
Sanitation				
Latrine	TPL with 1 drop-hole each for boys and girls	Currently in use	Service is grossly inadequate, generally clean, but unhygienic	 Adopt water-seal toilet design with 7 drop-holes each for boys and girls separate facility for teachers
Urinal	No provision		Urinal for boys is critical to avoid long waiting turns in already stretched latrines	 Provide ceramic finish and running water for easy cleaning

Service Type	Technology Option	Status	Comment	Proposed Improvement
Garbage Disposal	Open waste dump	Routinely burn	Indiscriminate burning of waste poses health risks	 Introduce garbage separation and composting practice
Handwashing	Plastic buckets located along school hall way	Water available but no soap	Handwashing facilities not located in or around toilet are less likely enhance the practice at critical times	 Introduce new toilet design with running water and HW facility within.
